# Mutton Cove:

## Levee breach risk assessment

**29 January 2015**

**Prepared for:** Natural Resources Adelaide & Mt Lofty Ranges

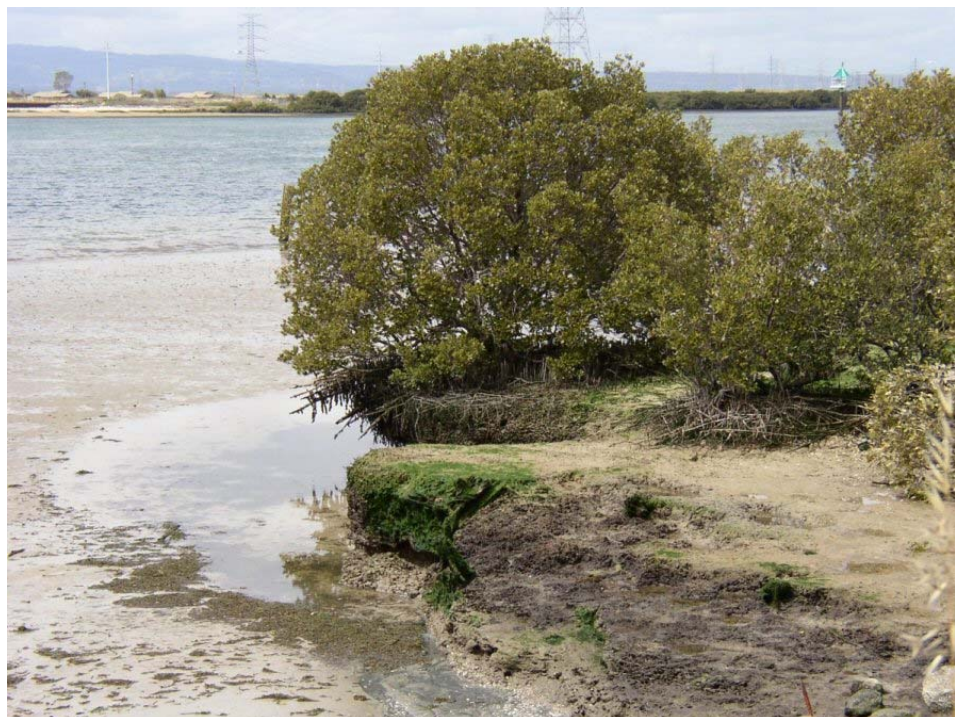
Figure 1 - Eroding stand of mangroves

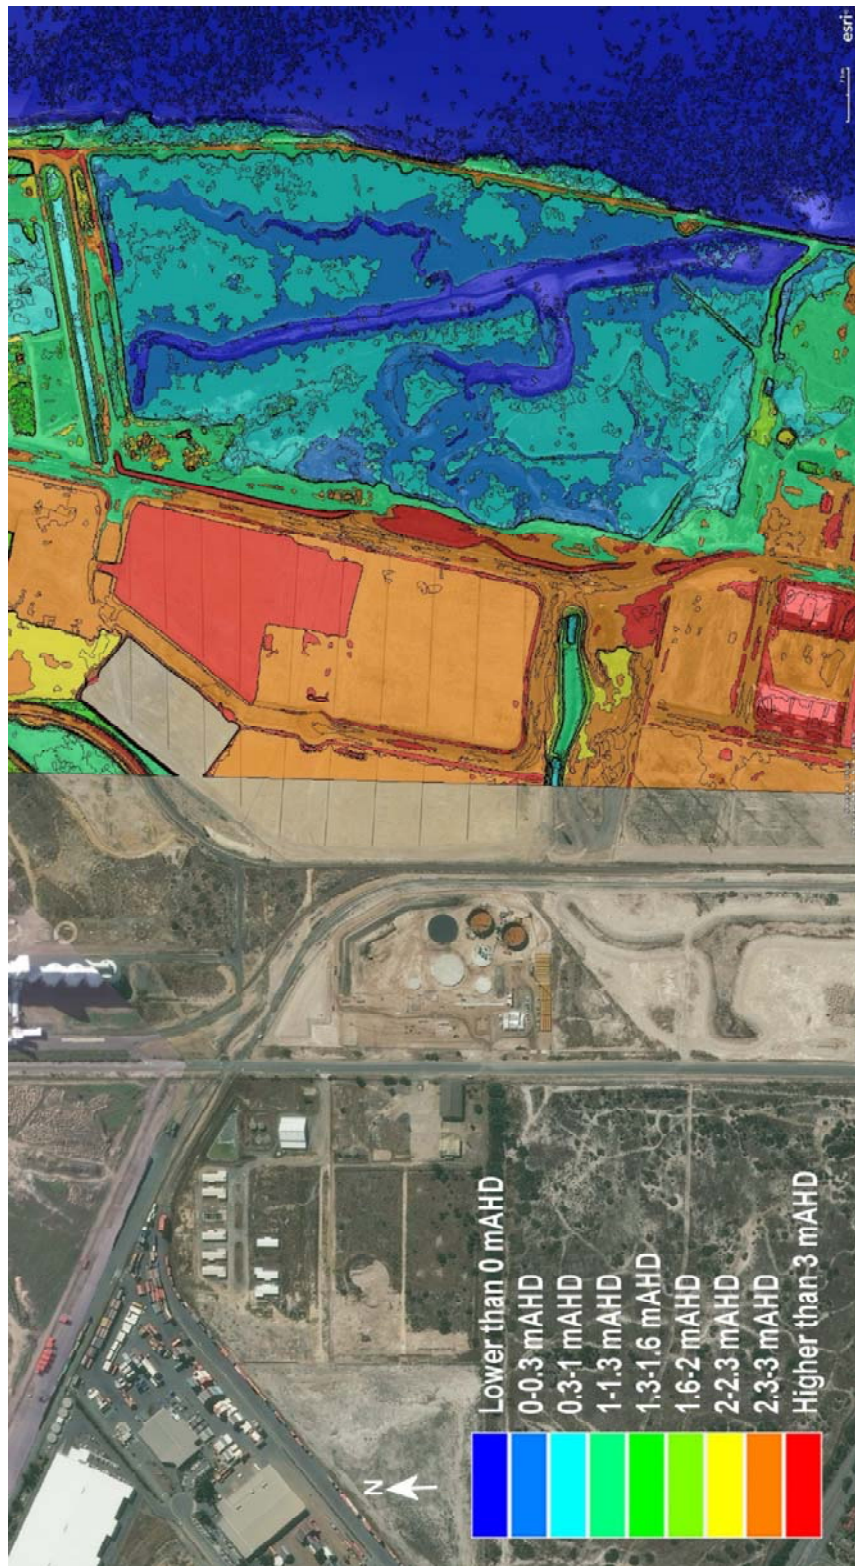
Figure 3 - Site topography, derived from LIDAR 2012

The LIDAR mapping confirms just how flat, and how subsided, the site is. The majority of the marsh plain is lower than 1.0 mAHD in elevation. In fact, most of the plain lies between 0.13 mAHD and 0.53 mAHD. The remnant areas of chenier and other small rises in the marsh plain do not exceed 1.3 mAHD. These account for less than 5% of the marsh plain area. Only the filled southern portion of the site and the bounding embankments exceed that height.

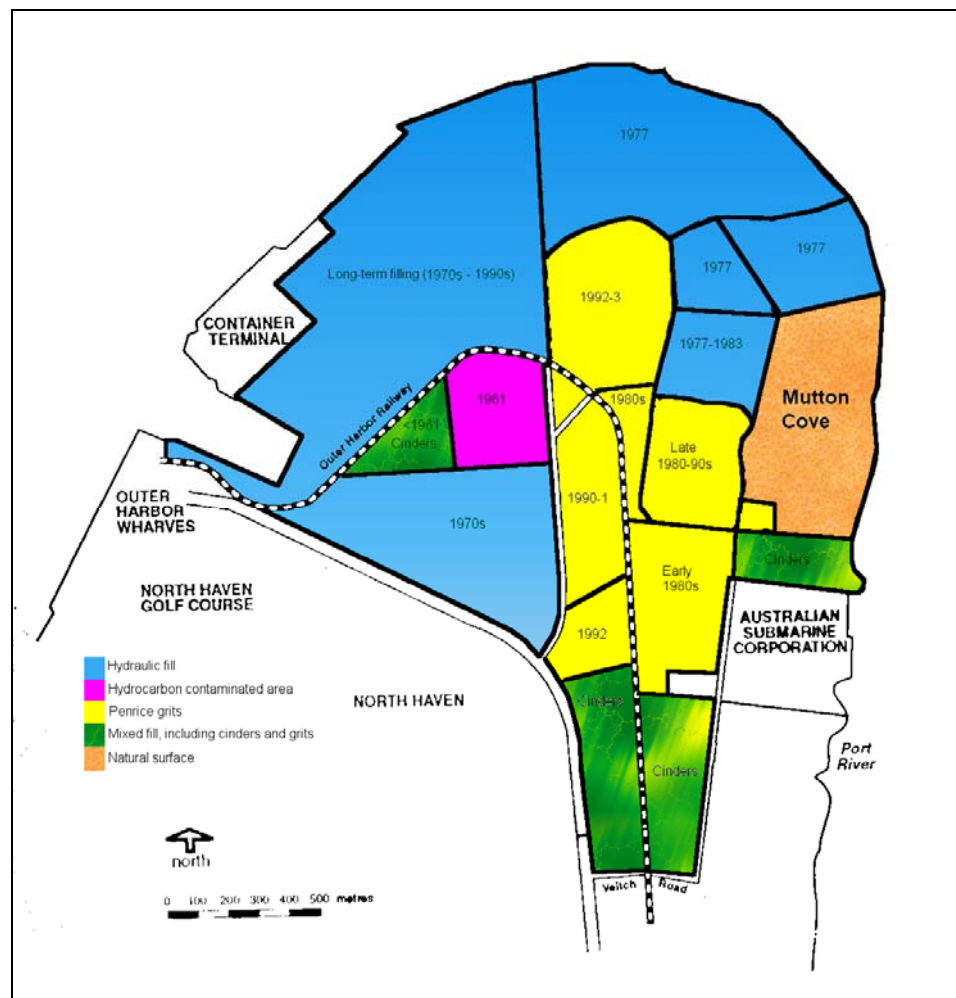
Figure 4 - Map of fill, derived from Maunsell (1995)

Maunsell's report (1995) found that the southern filled area of sandy soil at Mutton Cove was underlain by cinders and ash in a narrow strip inland of the seawall between the Mutton Cove Creek and the Australian Submarine Corporation.

Between Mutton Cove and Biodiversity Park both consultant reports recorded pyritic wastes from the Acid Plant at Taperoo, overlain with Penrice grits, an alkali waste. The most usual ions associated with sulfides as pyrites are iron and copper, however a blend of minerals such as silver, lead, zinc and arsenic may also form sulfides. These are known to occur in the southern Mt Lofty Ranges, for example silver-lead-arsenopyrites are found at Talisker and deposits of other metal sulfides are found at Brukunga in the Adelaide Hills. However, a soil sample taken by Kinhill Delfin (1991) close to this vicinity revealed no metals with concentrations above the Interim Urban Ecological Investigation limits or above the Health Investigation Limits for Recreational Areas (NEPC, 1999)

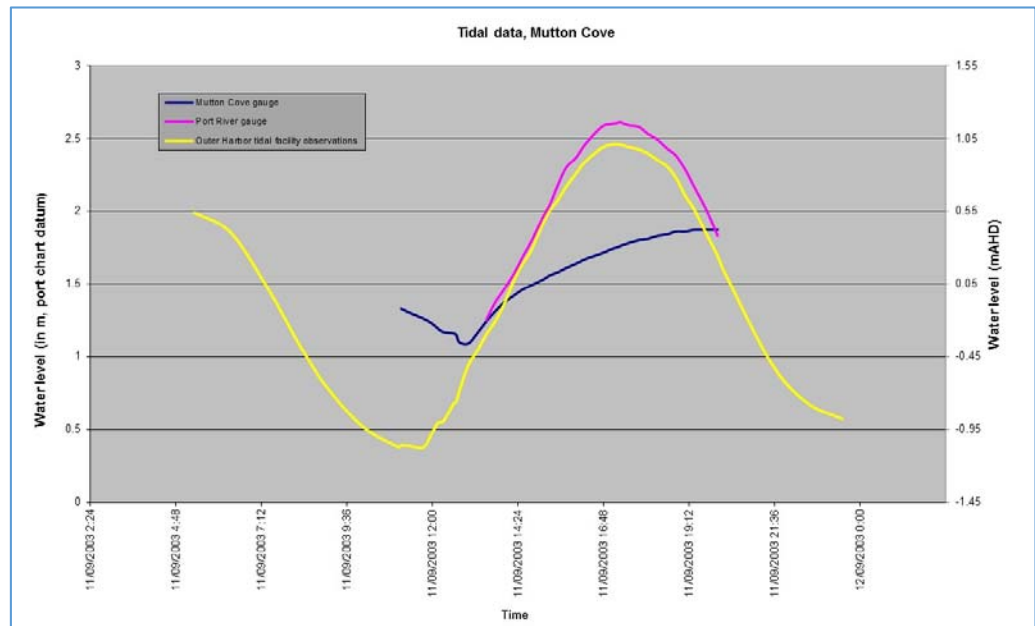
In 2003 there was about a 2 hour lag time for the tides inside the Cove when compared to those in the river, and the tides were truncated at the top and bottom of their range by about 0.75m (see Figure 6). The truncation of the top of the tide is entirely to do with the length of time of the lag – the rising tide inside the Cove intersects with the falling tide outside. It was considered that a reduction of lag time (by increasing flows into the Cove) would result in higher high tides. The truncation at the bottom of the tide was considered more recalcitrant, as the Cove can only drain out to an elevation that matches the bottom of the lowest pipe (approximately -0.4 mAHD). As the Cove drained to that level even with the restricted pipes it seemed unlikely that pipe rejuvenation would have any impact on the truncation of the low tide.

Figure 6 – Tidal restriction at Mutton Cove, 2003, prior to pipe restoration.
