# Mutton Cove:

## Levee breach risk assessment

**29 January 2015**

**Prepared for:** Natural Resources Adelaide & Mt Lofty Ranges

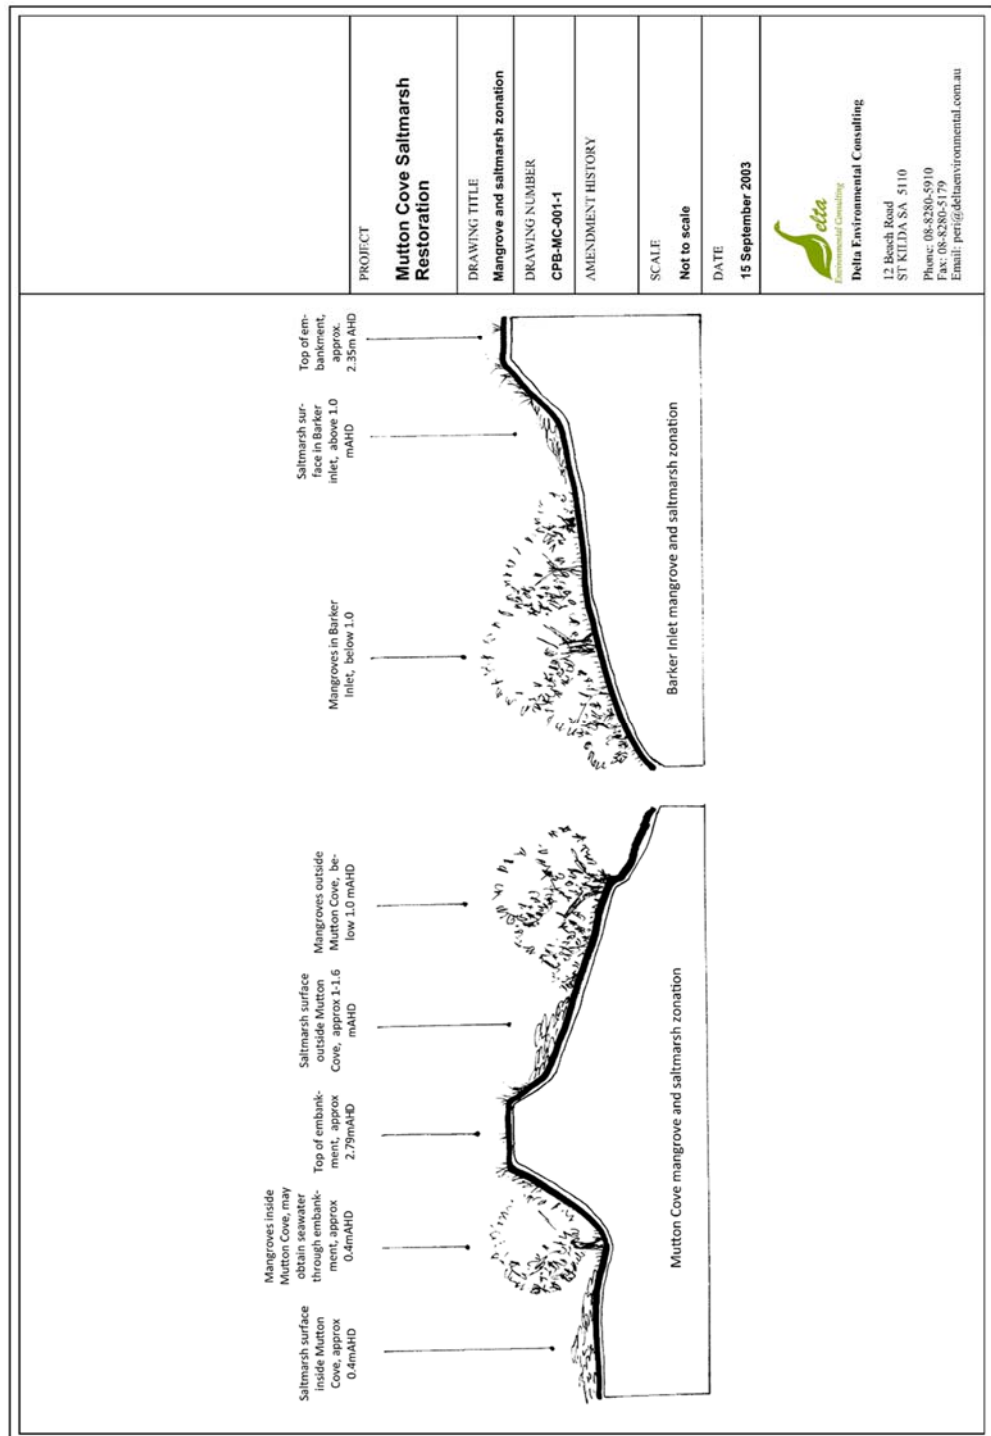
Figure 2 – Typical site cross section compared to tidally unrestricted sites (Cook & Coleman, 2003)

The resultant subsided marsh plane lay between 0.3 mAHD and 0.55 mAHD elevation. This was considerably lower than similar habitats that were not tidally restricted around Barker Inlet. Unrestricted tidal habitats tend to support mangroves below 0.95 mAHD and the lowest marsh plane grows on land above 0.95 mAHD. Figure 2, on the previous page, represents transects taken at unrestricted mangrove and saltmarsh sites in Barker Inlet, compared to a transect through Mutton Cove, from the mangroves and saltmarshes seaward of the impounding embankment and then across the impounded saltmarsh.

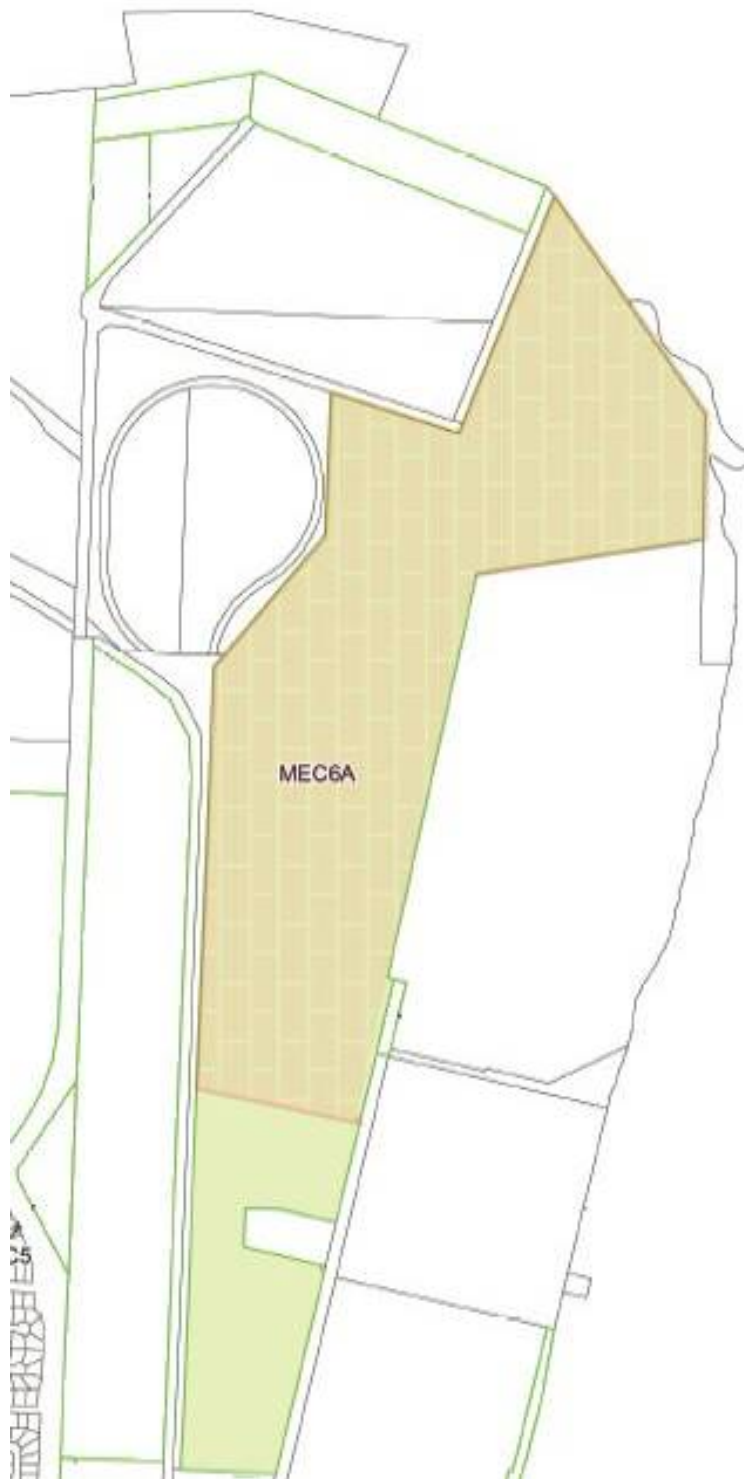
Since the reports undertaken in the 1990s there have been further changes in the nearby topography. When the Common User Facility (ship-lift) was being built after 2006, land between Mutton Cove and the railway was used as a disposal site (Figure 5) for the materials retrieved from the river during the dredging of the ship-lift pocket and the fitting-out berth pocket. These filled areas were then levelled and stabilized with grasses before being offered for sale for maritime industrial and supply uses.

Figure 5 - Dredge disposal site for CUF (designated MEC6a)
